Radio Bygones

Restoring A Novelty Brazilian Radio

by *Carlos Alberto Fazano*

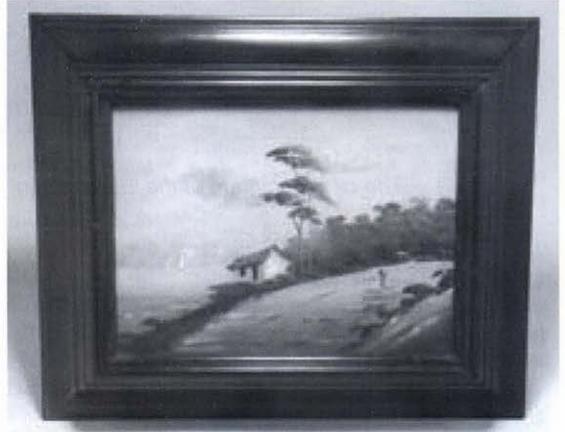
The picture radio

painting. The cabinet frame measures 49x41x10cm (width, length and depth).

As in many cabinets built in the early fifties and sixties, its frame is made in hardwood with accurate mitre joints, with carved details finished in a dark brown stain and lacquer combination that produces an elegant look. A wood panel, fixed with eight 3mm screws on the back of the cabinet, serves as baffle with a central hole covered by a grille where a four-inch loudspeaker is fixed. The panel has ventilation slots and also slots for the combined disc type volume/on-off control and the tuning dial in the lower left and right corners (see photo).

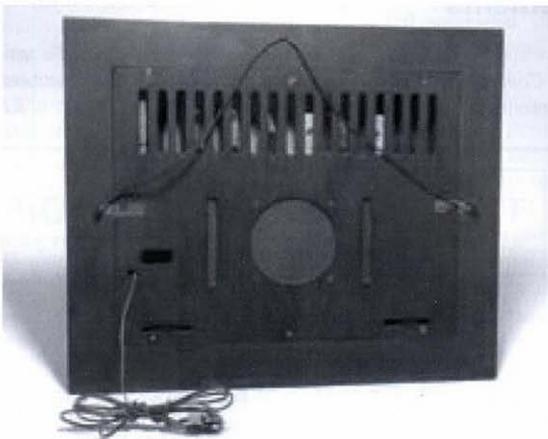
By removing the eight screws the back panel can be removed revealing a square wooden sub-assembly to which the radio chassis is fixed. The sub-assembly is used to accommodate a planar wound loop antenna. The ganged tuning capacitor and the combined volume/on-off potentiometer are mounted in an inner wood base that also supports the oil painting.

The back of the picture radio showing the loudspeaker grille and volume and tuning controls

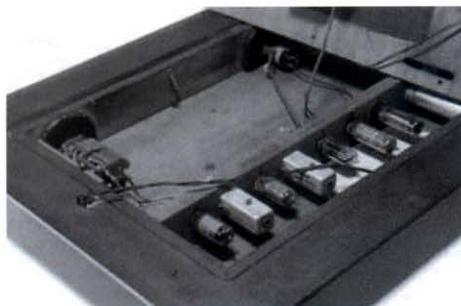
the aerial, enclosed in the wooden cabinet for safety reasons. The circuit is the basic 'All American Five' tuning 550 to 1600kHz and employing miniature valves: 12BE6 RF amplifier, 12BA6 IF amplifier, 12AV6 detector, 50C5 audio amplifier and 35W4 rectifier.

The chassis housing the miniature valves

By studying the valve complement I estimate that the picture radio was manufactured in the late fifties. But, in spite of its age, the set was not in a bad shape. As in any restoration appearance and electrical performance were considered. The radio was carefully disassembled on the work bench. Restoration started by checking all the passive components and defective ones were replaced accordingly. The power cord was cleaned with a detergent solution to remove the accumulated greasy dirt; the cord connections in the male plug were checked and re-made. Unfortunately, all the valves except the 35W4 rectifier were burnt and had to be replaced by a new pre-tested set from the author's own inventory.

The electro-mechanical parts such as volume/on-off control and valve sockets were checked and treated with contact cleaner. Valve-socket contact tension was restored by applying pressure with a dentist's pick. Besides a thin layer of dust, the loudspeaker and its output transformer were in a good condition. The dust accumulated on the loudspeaker paper cone was cleaned carefully with a soft brush and its rusted four fixing screw, bolts and washers were replaced by new ones.

As this is an AC/DC set it was connected for testing through an isolation transformer. Following the replacement of the valves and a few passive components the set came to life. The only extra change needed was to the noisy volume control which required a second cleaning.
